**Flood Control Project Maintenance
Levee Inspections**

Fall 2011 Levee Maintenance Deficiency Summary Report

Reclamation District No. 0551 Pearson

Levee Inspection Report By Mile - Fall 2011

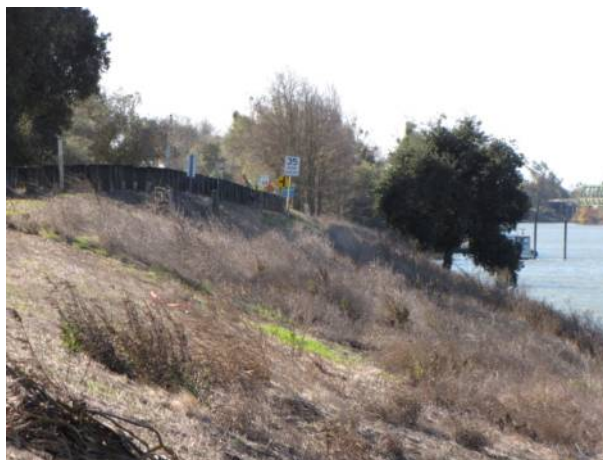
Levee Mile Report Line	1
Start Levee Mile	0.00
End Levee Mile	0.00
Location	Water Side
Category	Earthen Levee
Item	Vegetation

RD 551 looking downstream from waterside levee mile 0.00. Photo taken 11-30,-2011.

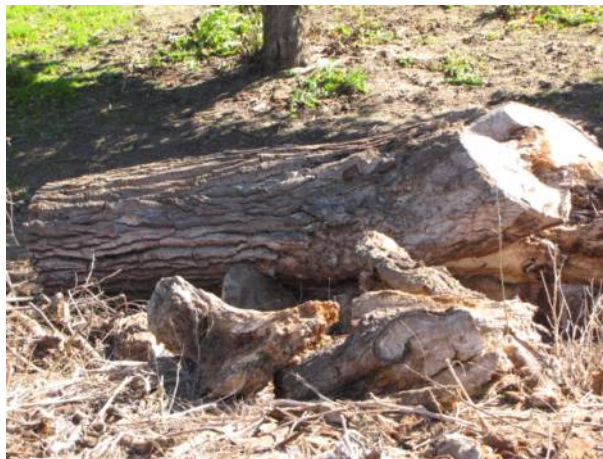
Levee Mile Report Line	3
Start Levee Mile	0.20
End Levee Mile	0.20
Location	Land Side
Category	Earthen Levee
Item	Encroachments

Landside levee mile 0.20 cut up tree sections on toe. Photo taken 12-01-2011.

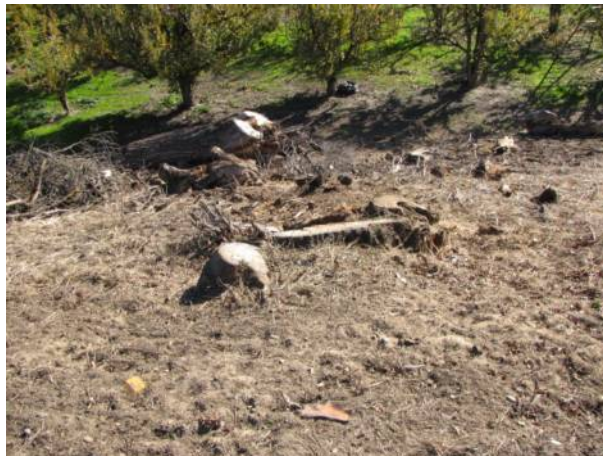
Levee Mile Report Line	4
Start Levee Mile	0.20
End Levee Mile	0.20
Location	Land Side
Category	Earthen Levee
Item	Trim / Thin Trees

Tree stumps landward toe. Levee mile 0.20. Photo taken 12-01-2011.

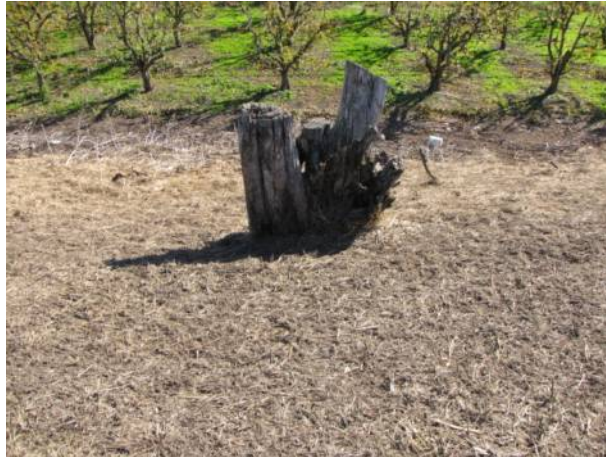
Levee Mile Report Line	5
Start Levee Mile	0.22
End Levee Mile	0.22
Location	Land Side
Category	Earthen Levee
Item	Trim / Thin Trees

Levee mile 0.22 landside. Photo taken 12-01-2011.

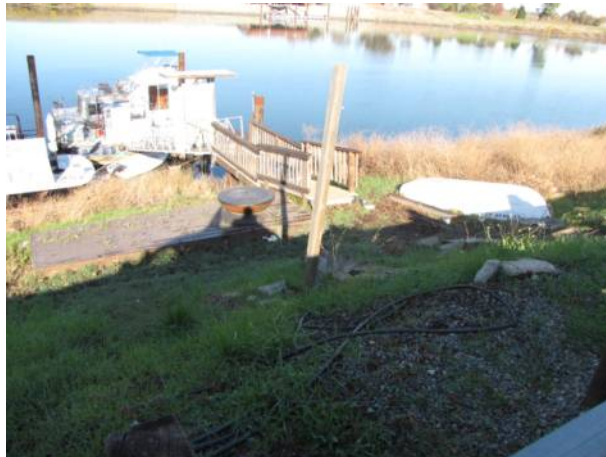
Levee Mile Report Line	12
Start Levee Mile	0.70
End Levee Mile	0.73
Location	Water Side
Category	Earthen Levee
Item	Encroachments

Gangway, wooden platform, and boat on berm and dock.

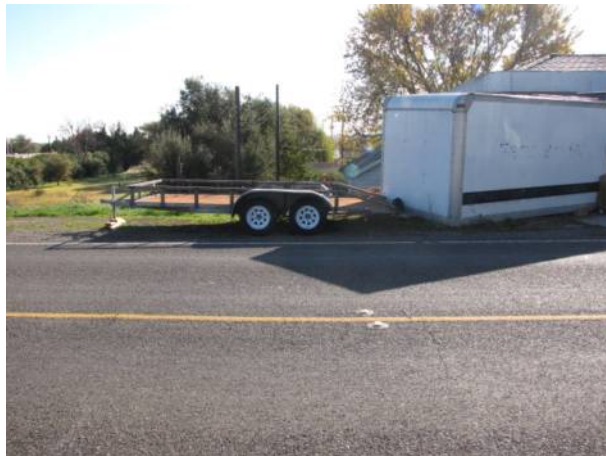
Levee Mile Report Line	12
Start Levee Mile	0.70
End Levee Mile	0.73
Location	Water Side
Category	Earthen Levee
Item	Encroachments

Boat trailer and box trailer on landward shoulder.

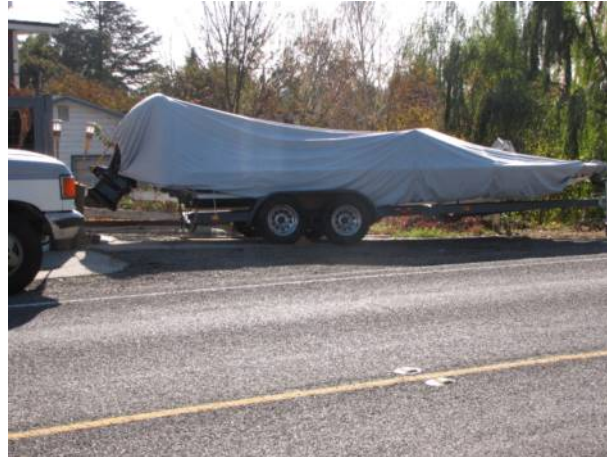
Levee Mile Report Line	12
Start Levee Mile	0.70
End Levee Mile	0.73
Location	Water Side
Category	Earthen Levee
Item	Encroachments

Boat and trailer on land side shoulder.

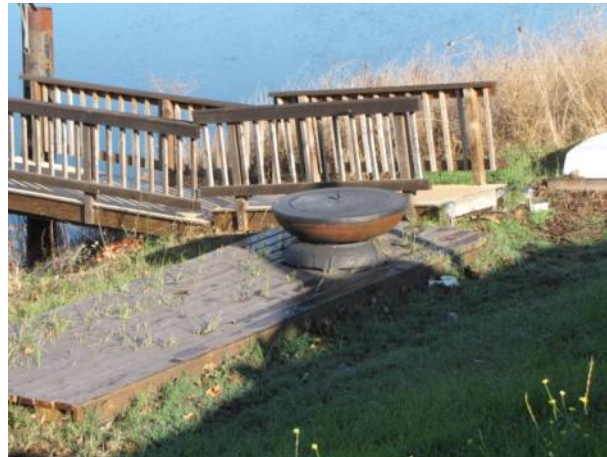
Levee Mile Report Line	12
Start Levee Mile	0.70
End Levee Mile	0.73
Location	Water Side
Category	Earthen Levee
Item	Encroachments

Another view of the gangway and the platform.

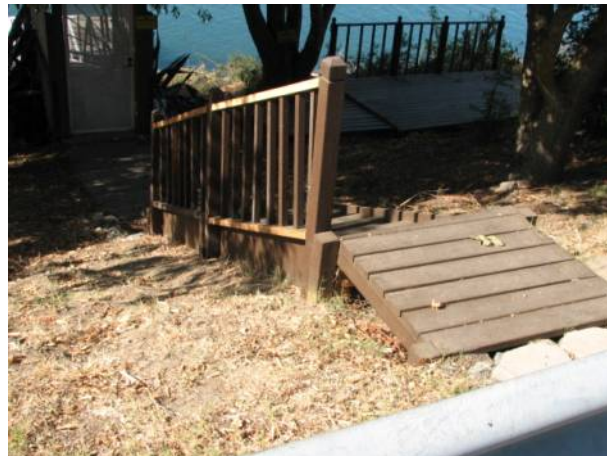
Levee Mile Report Line	13
Start Levee Mile	0.76
End Levee Mile	0.76
Location	Water Side
Category	Earthen Levee
Item	Encroachments

This stairway was placed on the levee section without a Rec. Board permit. In the far background is a wooden deck on the levee slope.

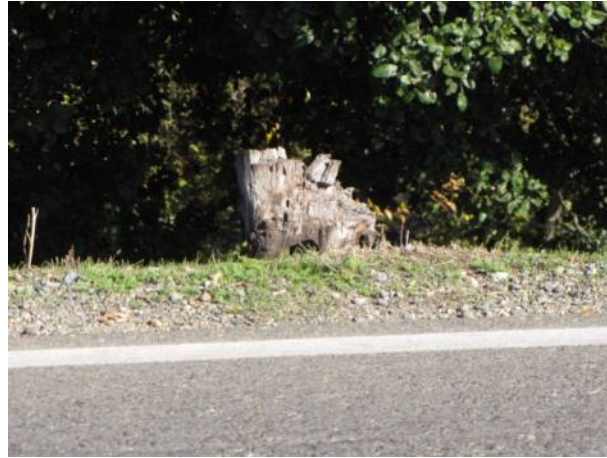
Levee Mile Report Line	19
Start Levee Mile	2.75
End Levee Mile	2.75
Location	Land Side
Category	Earthen Levee
Item	Trim / Thin Trees

Tree stump levee mile 2.75 landward shoulder.
Photo taken 12-01-2011.
